RE: **ATP SURFACE SWABS SAMPLING REPORT**
LOCATION: 607 15 Avenue, Nisku, Alberta
APSR JOB #: 2021-51 Hygiene

Enclosed is AP Solutions and Resources (APSR) Environmental Health & Safety's final report for the adenosine triphosphate (ATP) surface swab testing for the Electric HP site located at 607 15 Avenue in Nisku, AB.

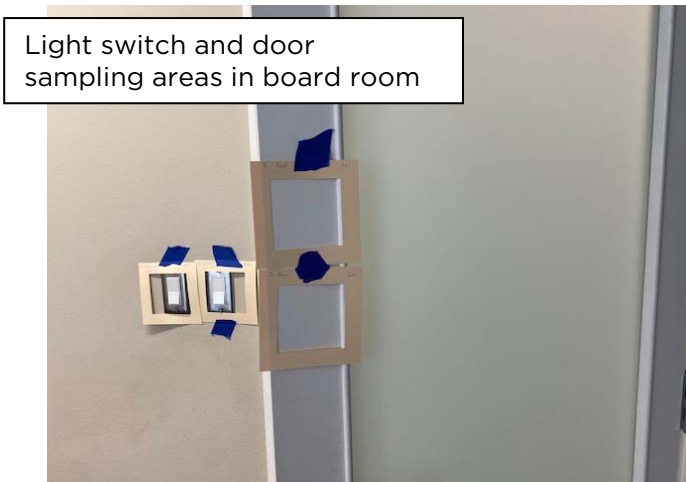
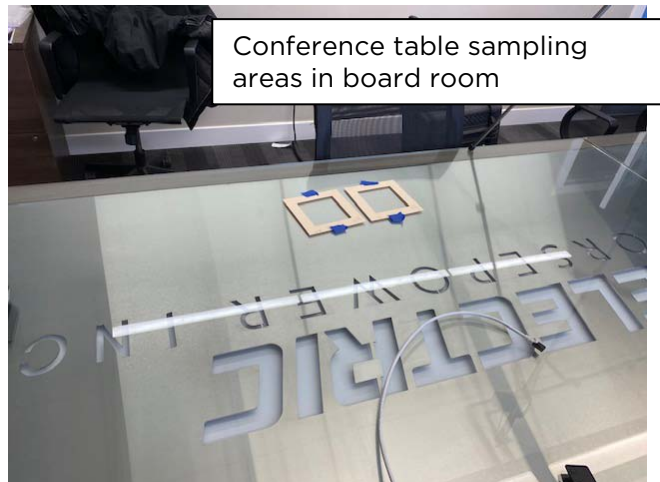
The post surface swab area samples collected on the following surfaces indicated a reduction in RLU measurements between pre- and post-application sampling:

1. Sample 2 - Light switch
2. Sample 3 - Door
3. Sample 7 - Conference table (SW)

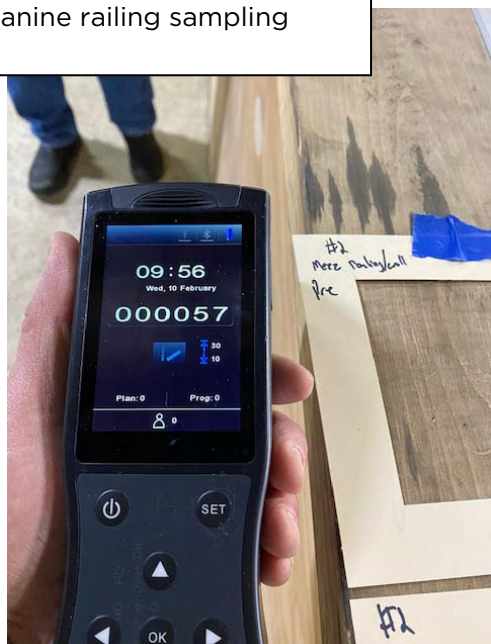
Mezzanine railing sampling area

Sample Number	Sample Location	ATP Measurement Pre (RLU)	ATP Measurement Post (RLU)
1	Lunch room fridge (mezzanine)	15	NA
2	Mezzanine railing wall	57	28
3	Resistance heater NE	11	NA
4	SE door	16	NA
5	SW door	18	NA
6	Welding table	33	9
7	Shipping/Receiving door	97	6
8	Lower rack (north)	19	NA
9	Middle rack (centre)	18	NA
10	Upper rack (south)	104	49

1. Sample 2 - Mezzanine railing wall
2. Sample 6 - Welding table
3. Sample 7 - Shipping/Receiving door
4. Sample 10 - Upper rack (south)

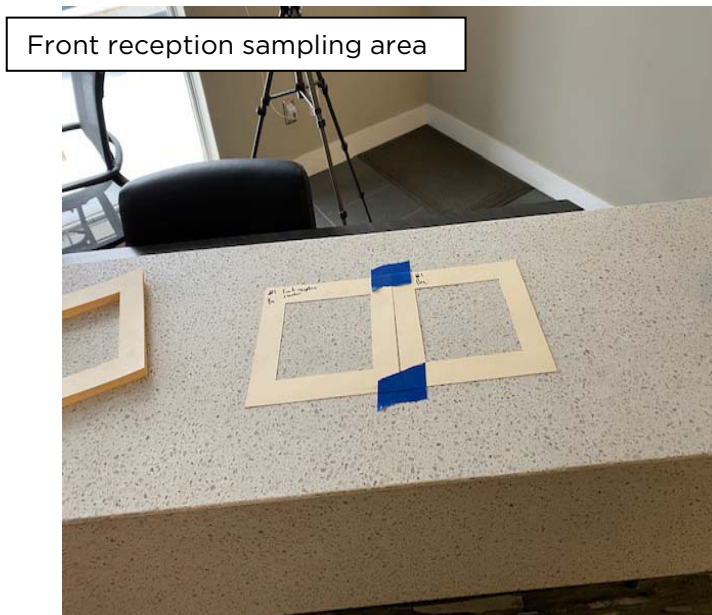
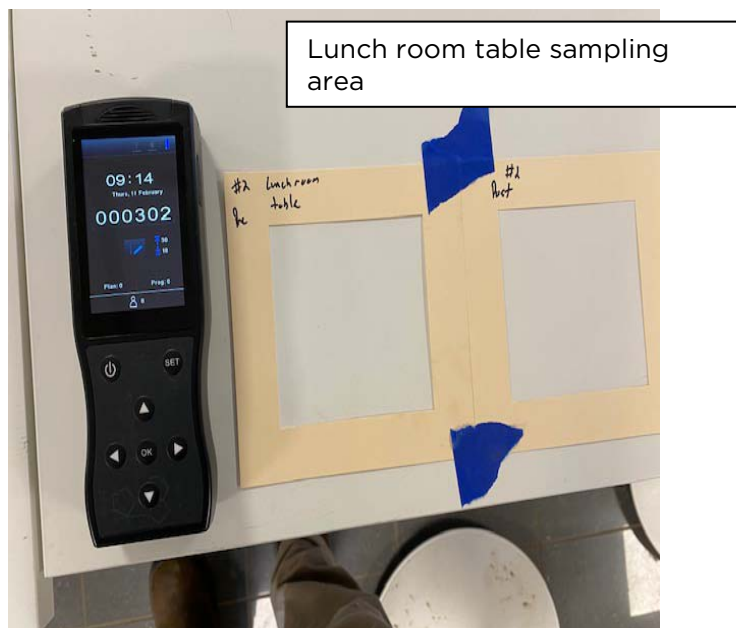
The post surface swab area samples collected on the following surfaces indicated a reduction in RLU measurements between pre- and post-application sampling:

1. Sample 1 - Front reception desk
2. Sample 2 - Lunch room table
3. Sample 3 - Centre hallway door
4. Sample 6 - SW office desk (Rob's)

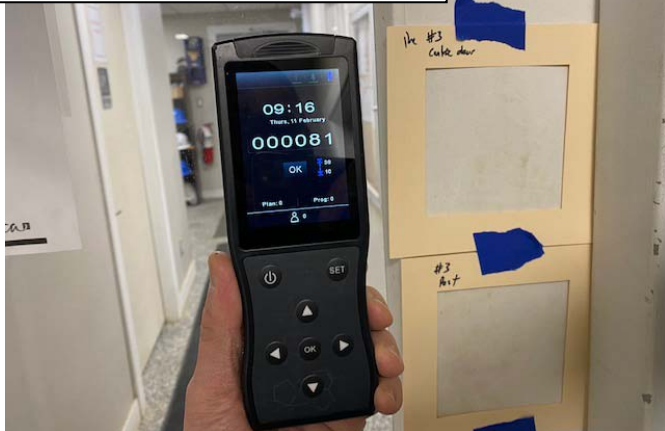
Centre hallway door sampling area

Sample Number	Sample Location	ATP Measurement Pre (RLU)	ATP Measurement Post (RLU)
1	Front reception desk	108	22
2	Lunch room table	302	1
3	Centre hallway door	81	29
4	Black lockers	9	NA
5	Lunch room fridge door	11	NA
6	SW office desk (Rob's)	128	64
